**2001 ANNUAL INSPECTION REPORT
RCRA UNITS
FORMER PROTECO FACILITY
PEÑUELAS, PUERTO RICO**

Project Number 12000-1-0141

November 13, 2001

Subject: PROTECO ID# PRD091018622
2001 Annual Inspection Report

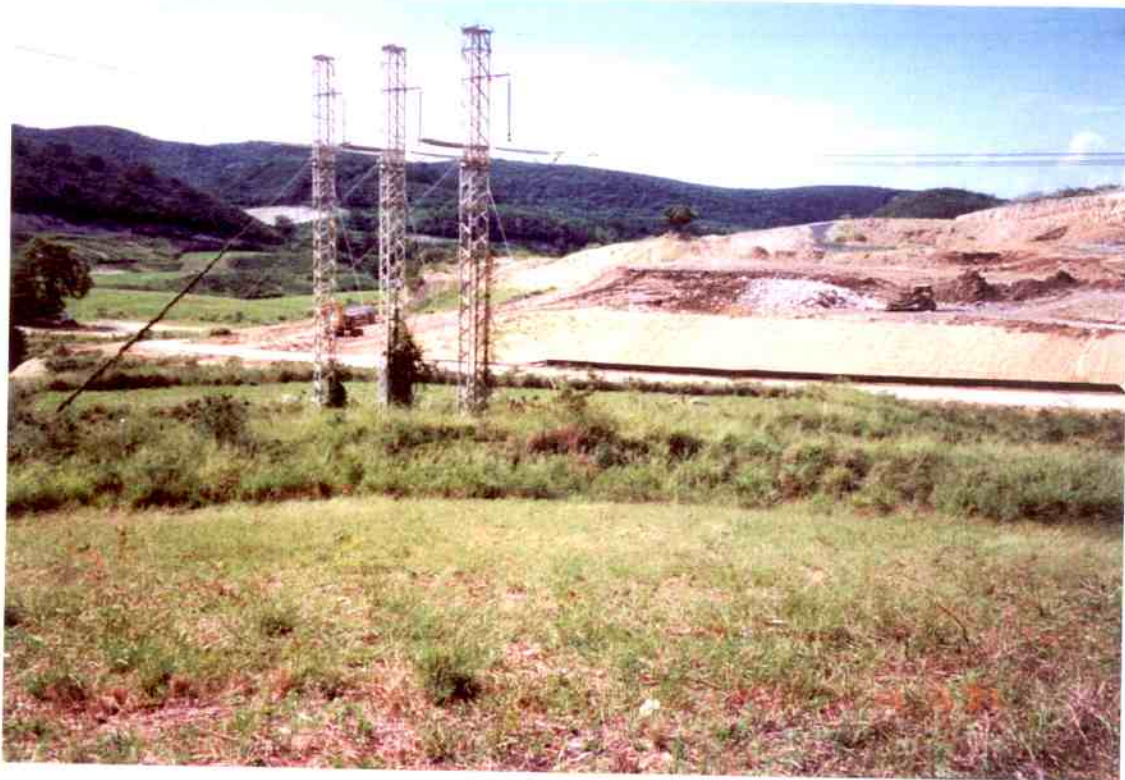
View of Unit 5 Looking Southeast from Unit 2/3

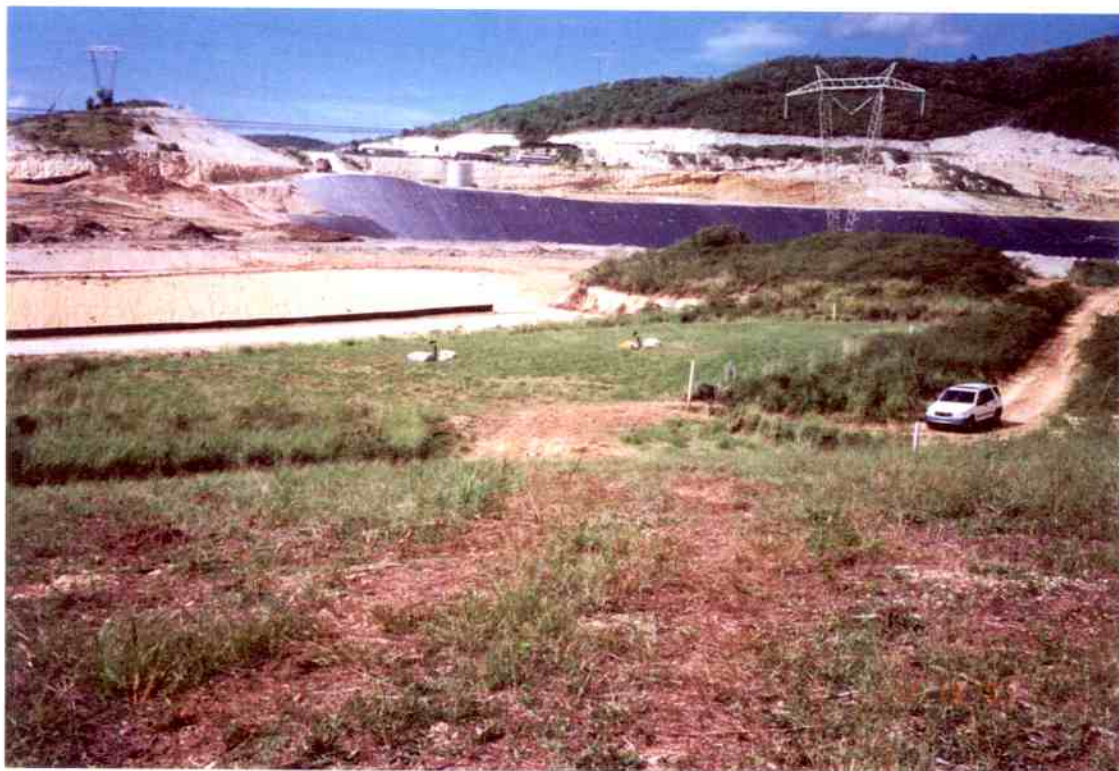
View of Unit 1 Looking Southwest from Unit 2/3

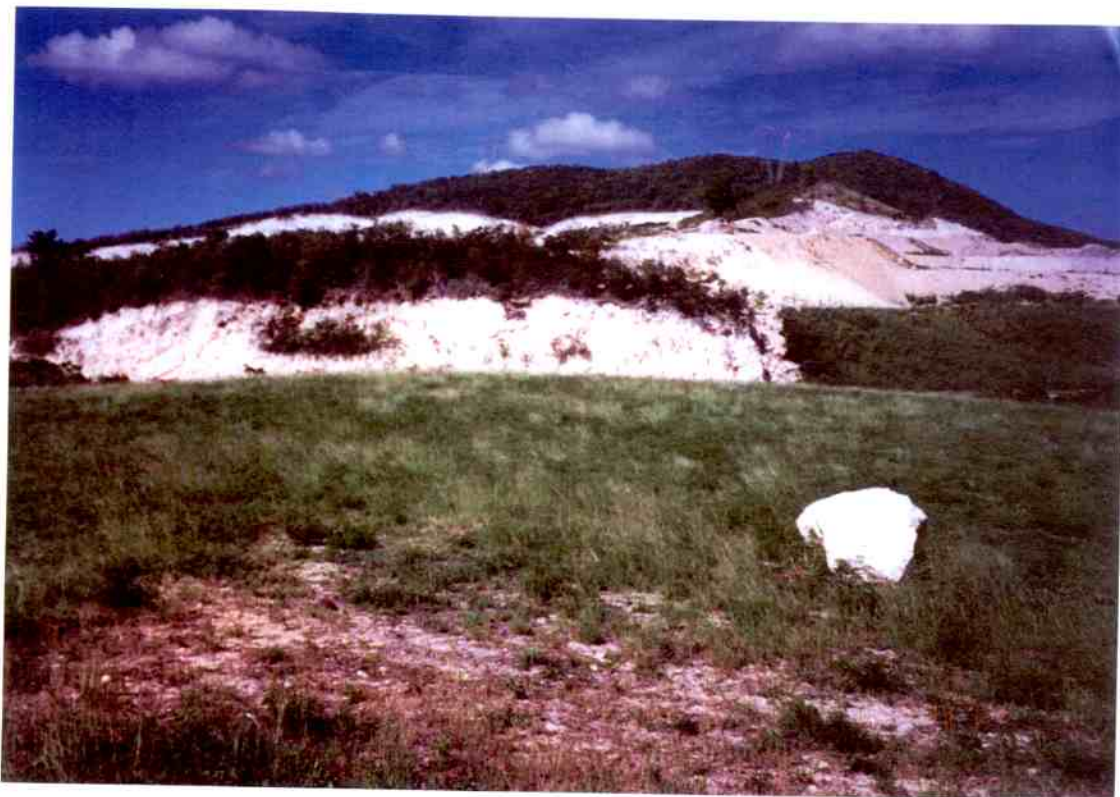
View of Top of Units 9 & 10/11 Looking West

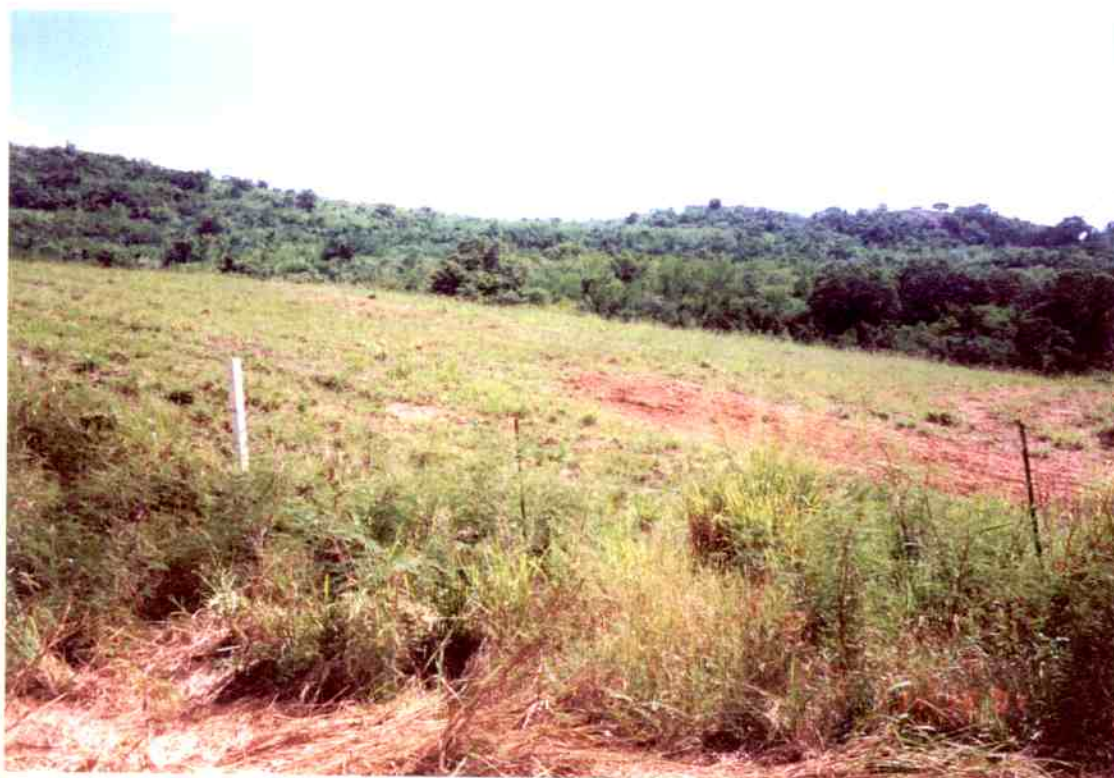
View of South Slope of Unit 2/3 Looking East from By-Pass Diversion Ditch

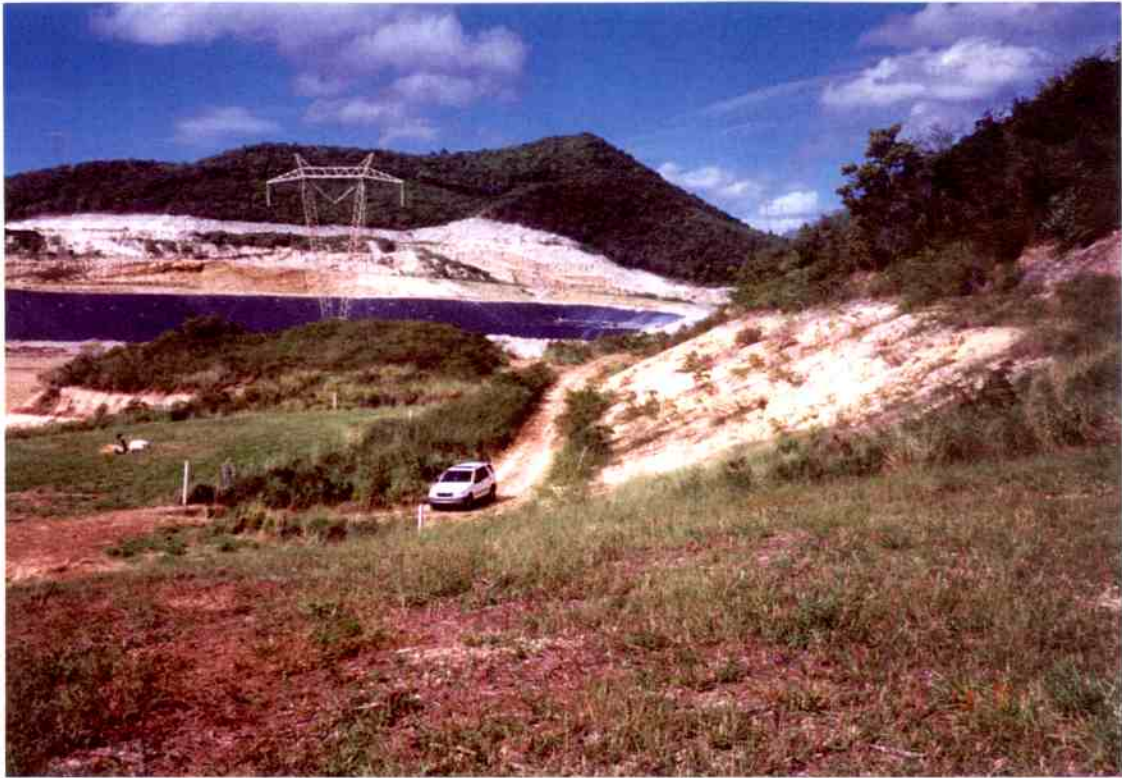
View of Unit 1 and South Slope of Unit 2/3 Looking Southwest

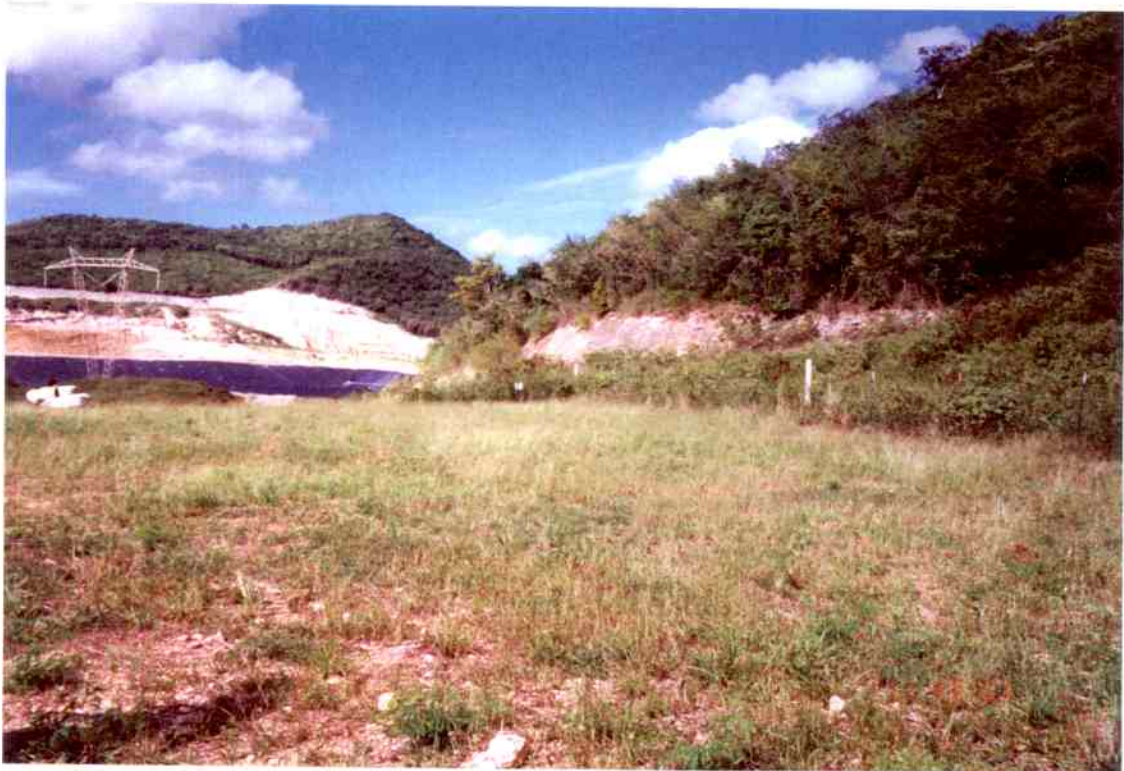
View of Top of Unit 2/3 Looking Southwest

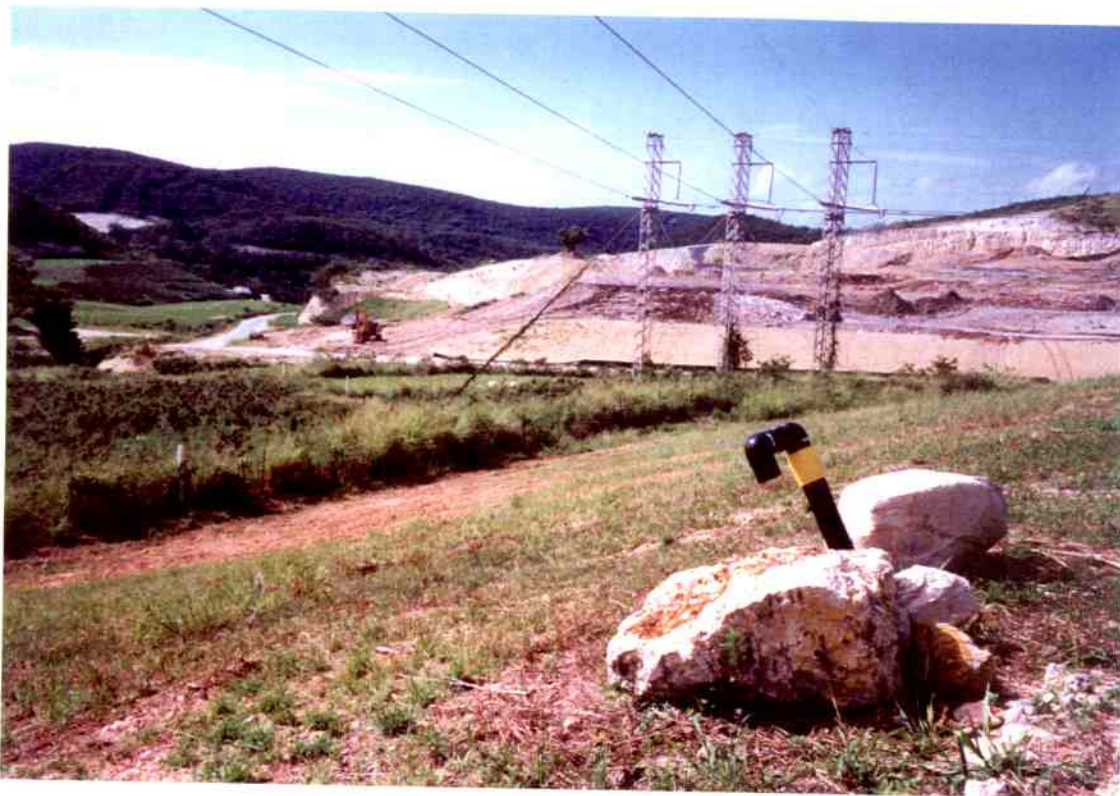
View of East Slope of Unit 2/3 Looking Southeast

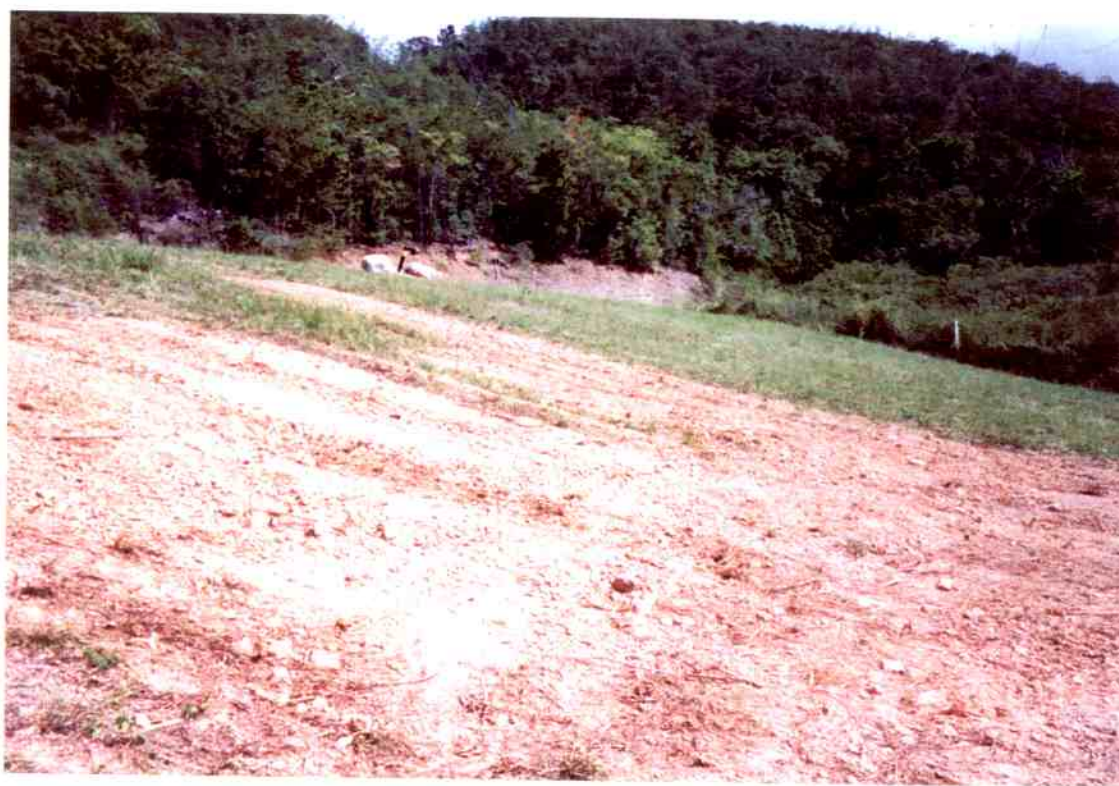
View of Recent Maintenance Activity on East Slope of Unit 2/3

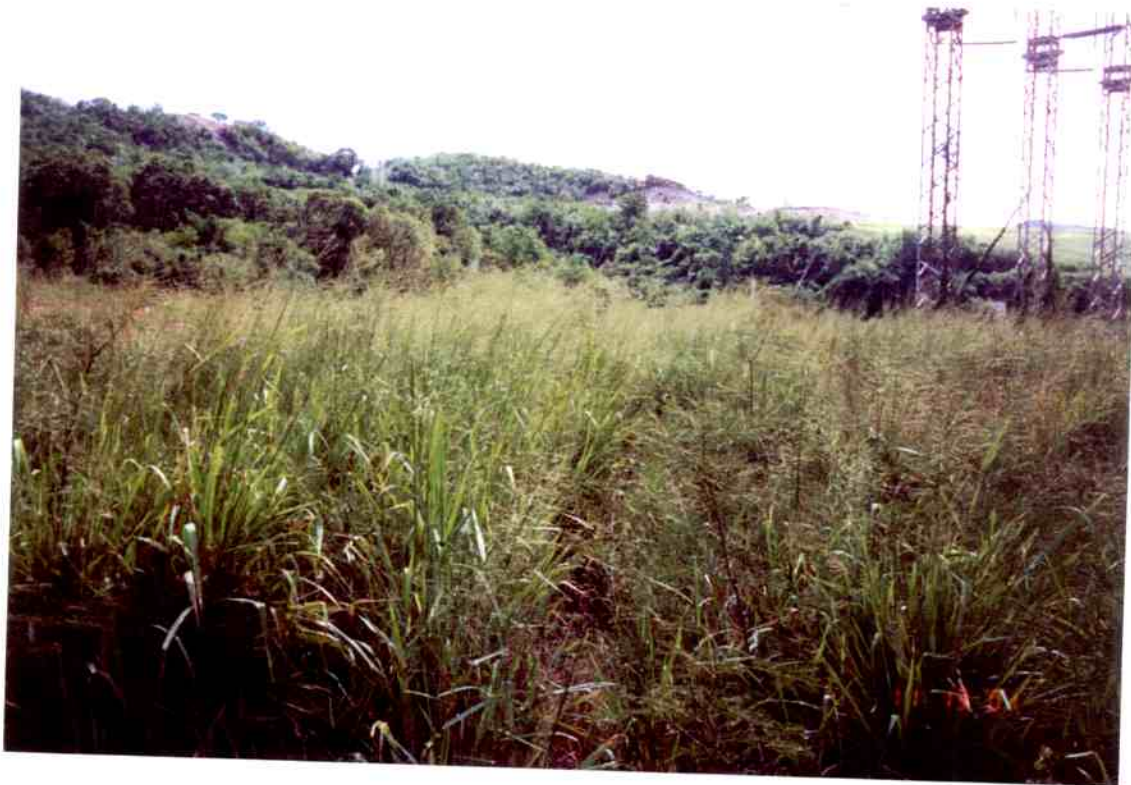
View of By-Pass Diversion Ditch Between Units 1 and 2/3 Looking East

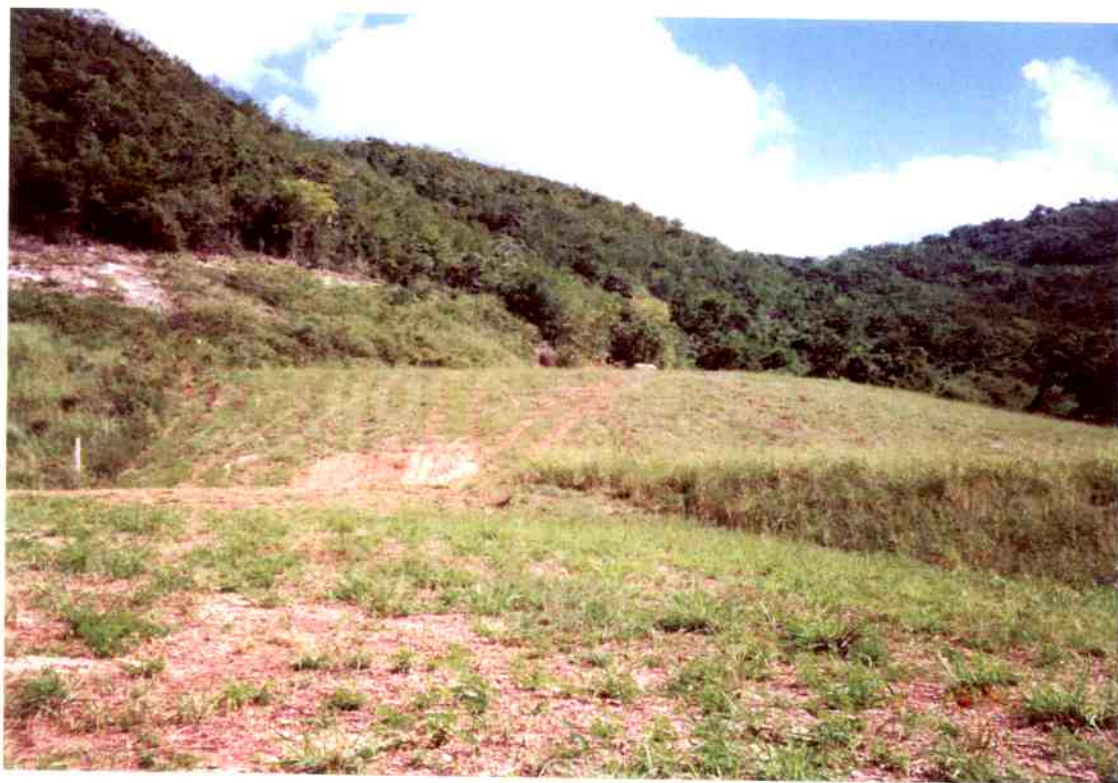
View of Top of Unit 1 and South Slope of Unit 2/3 Looking North

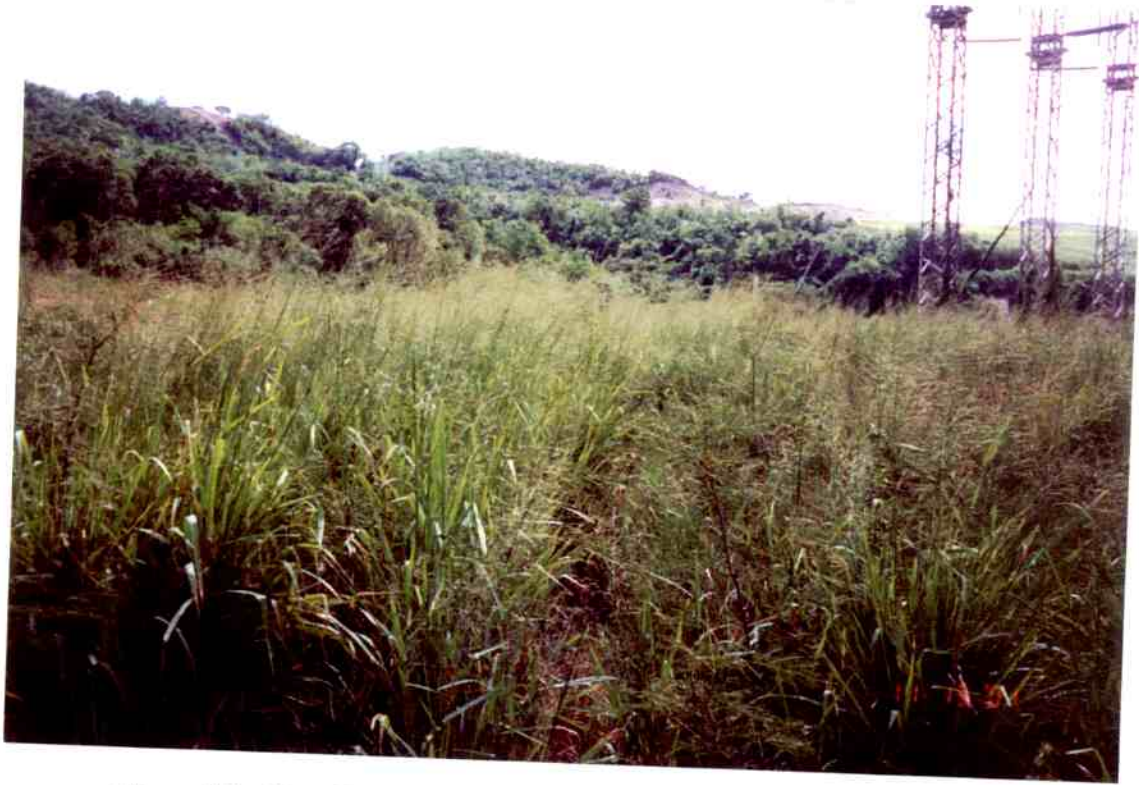
View of By-Pass Diversion Ditch Between Units 1 and 2/3 Looking East

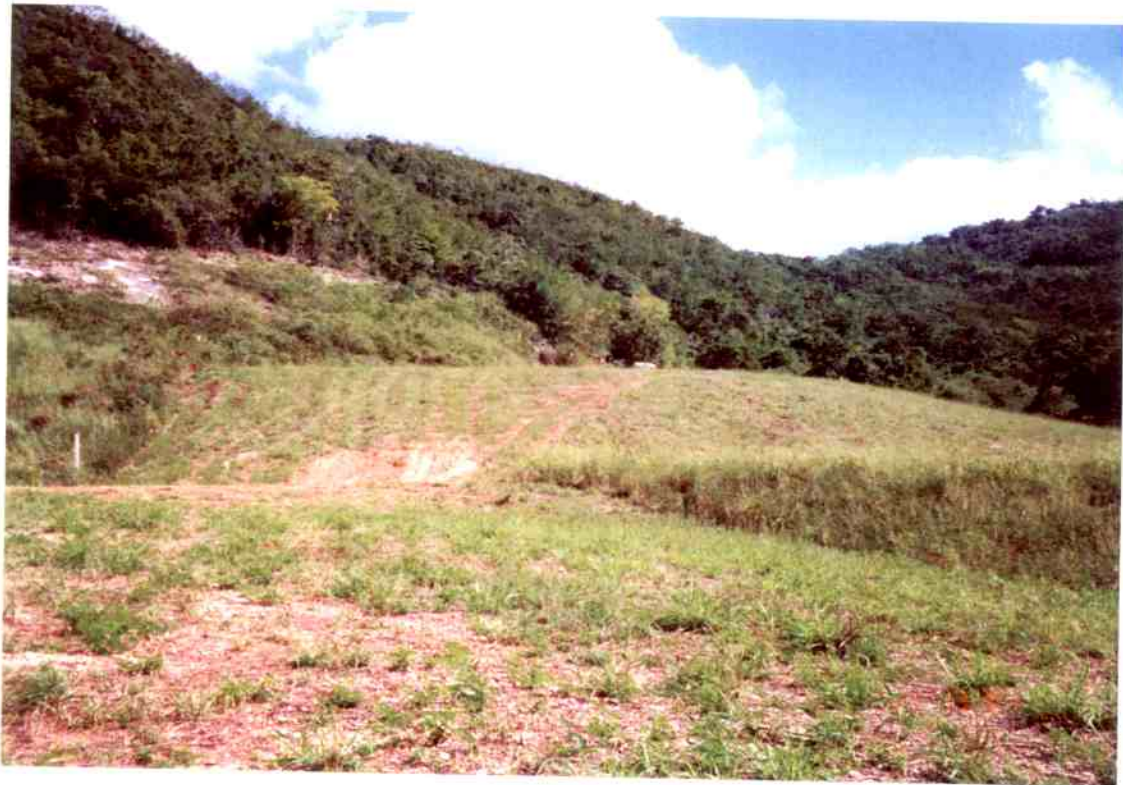
View of Top of Unit 1 and South Slope of Unit 2/3 Looking North

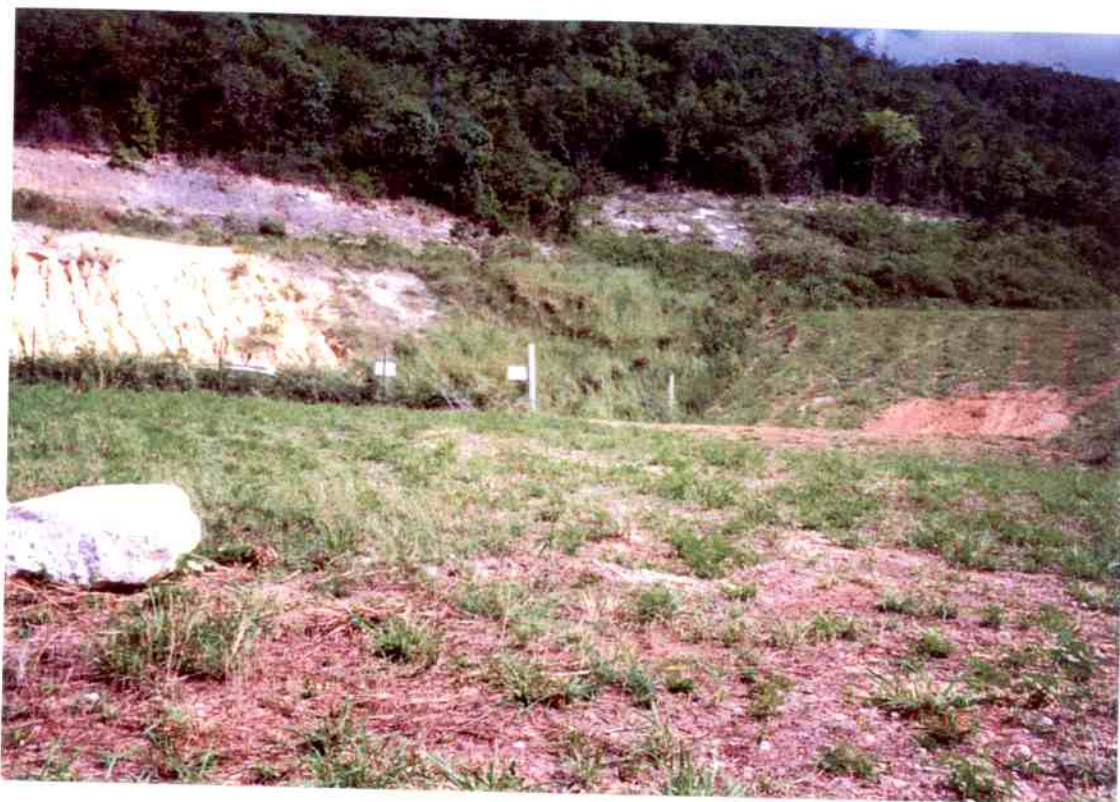
View of Top of Unit 1 and South Slope of Units 2/3 Looking North

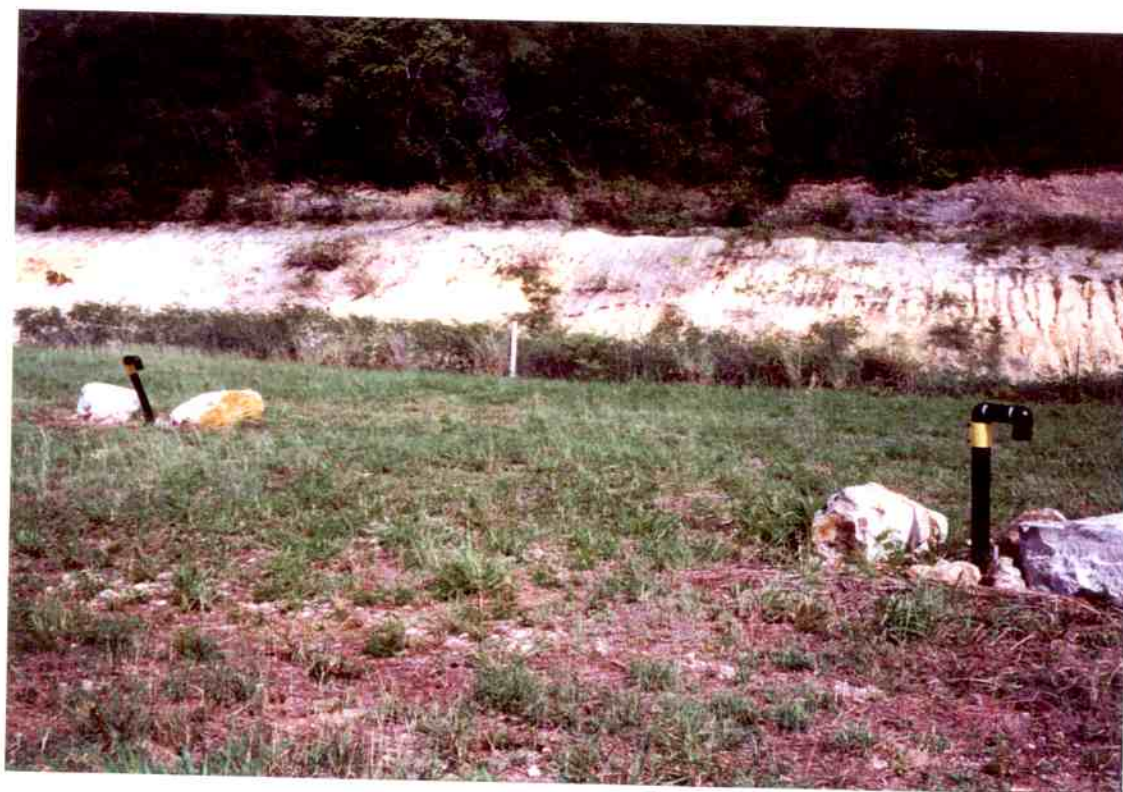
View of Top of Unit 1 Looking Northwest

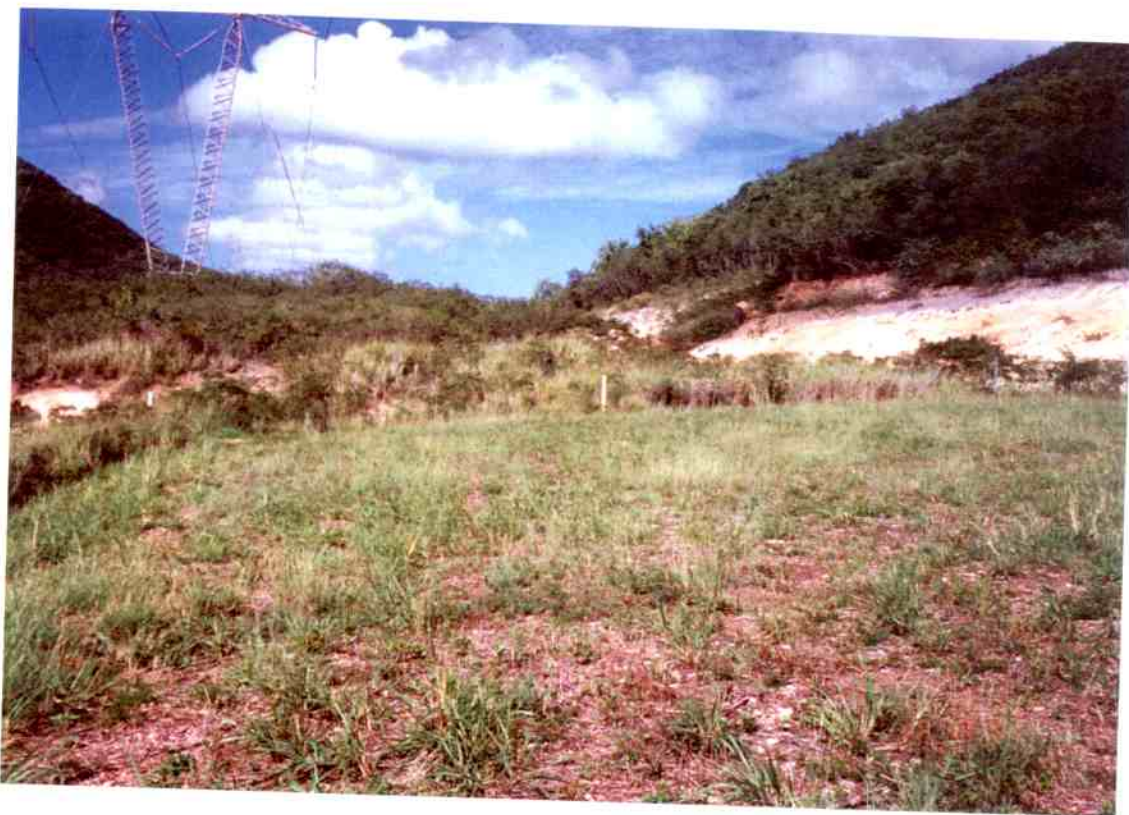
View of Top and South Slope of Unit 1 Looking West

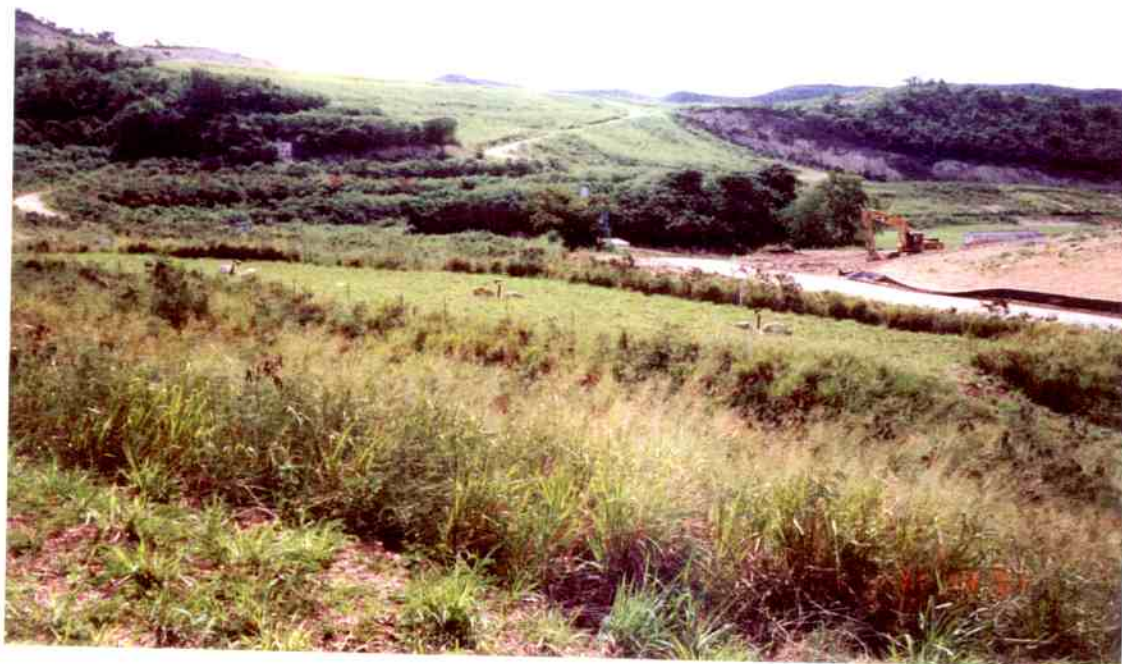
View of Unit 5 Looking Southeast from Unit 2/3

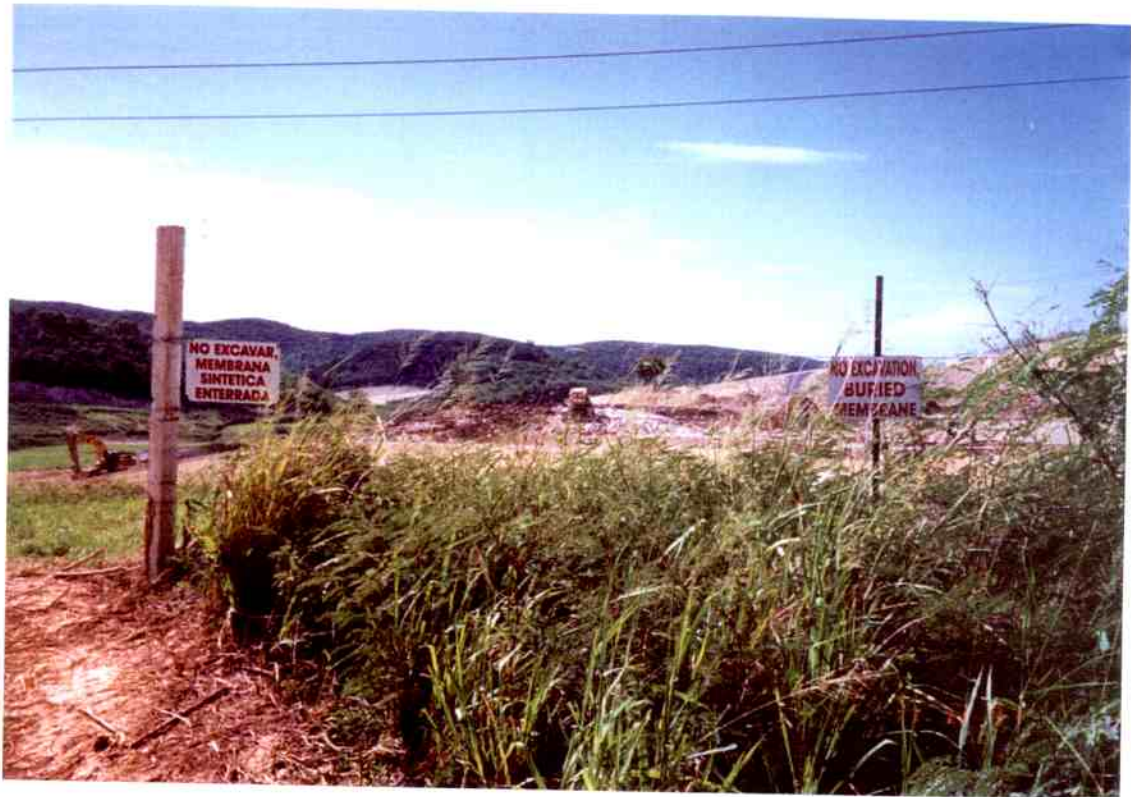
View of Fencing and Warning Signs

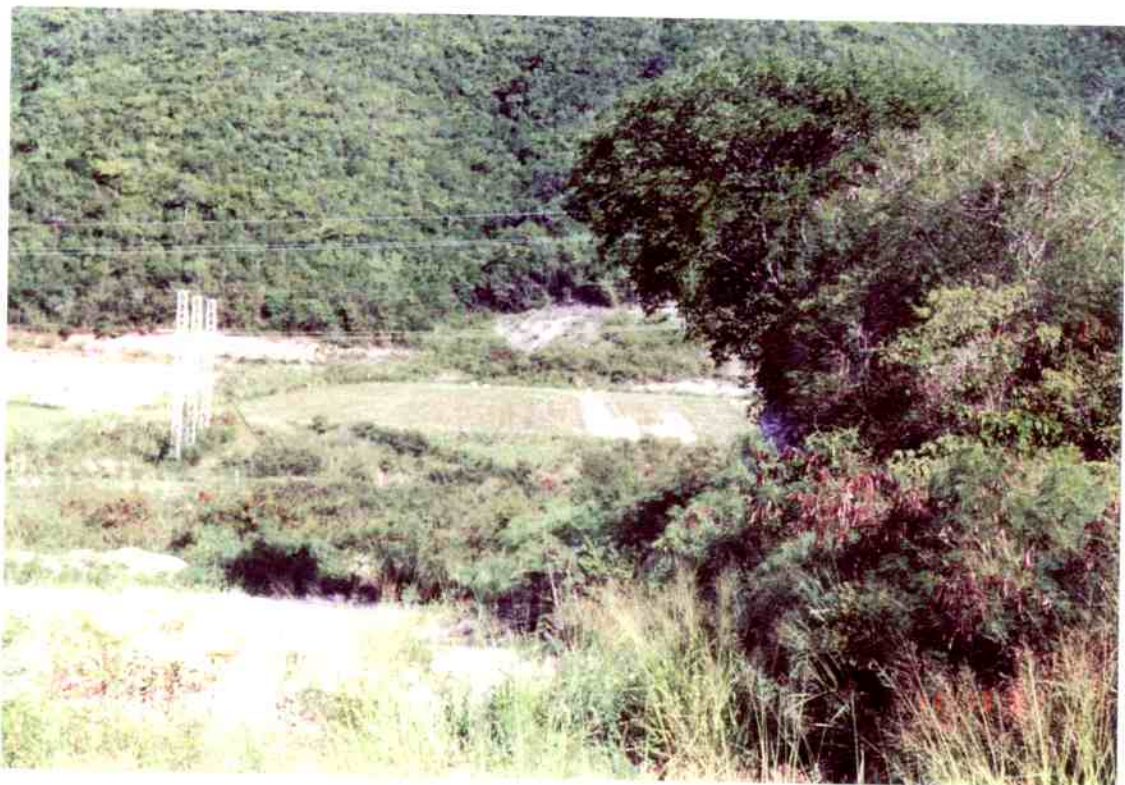
View of Recent Maintenance Activity on East Slope of Unit 2/3 Looking Northwest

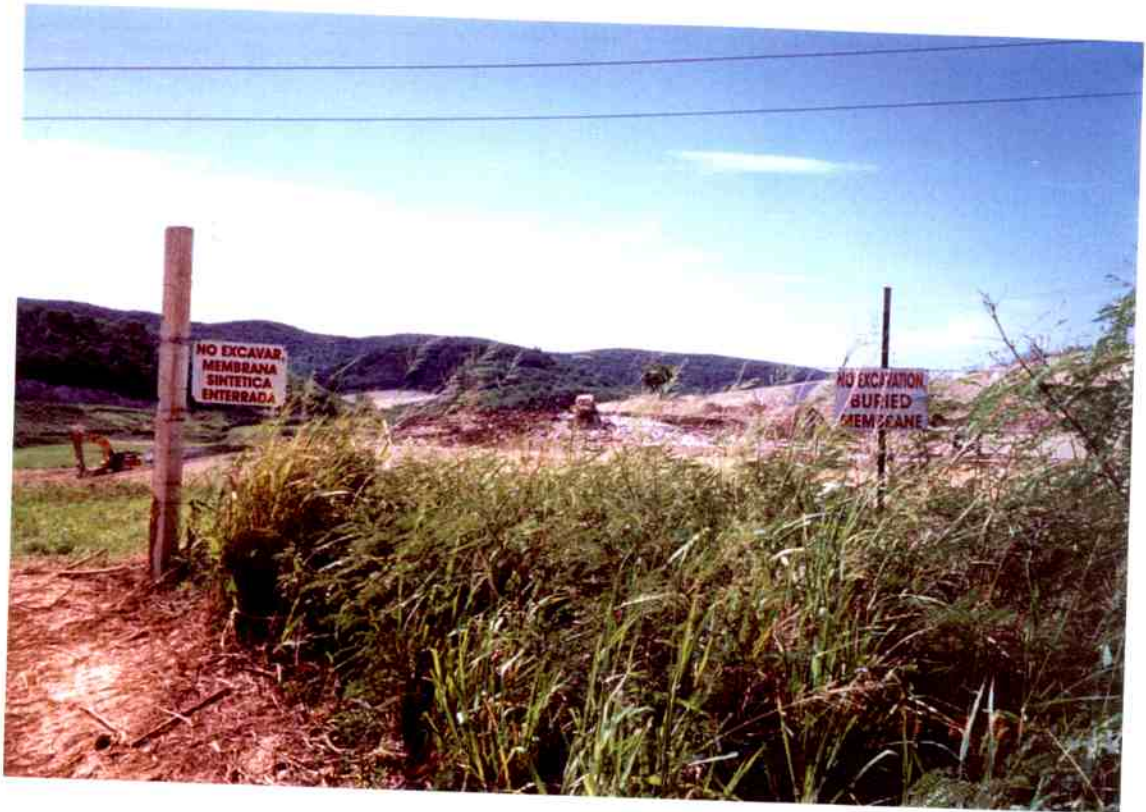
View of Fencing and Warning Signs

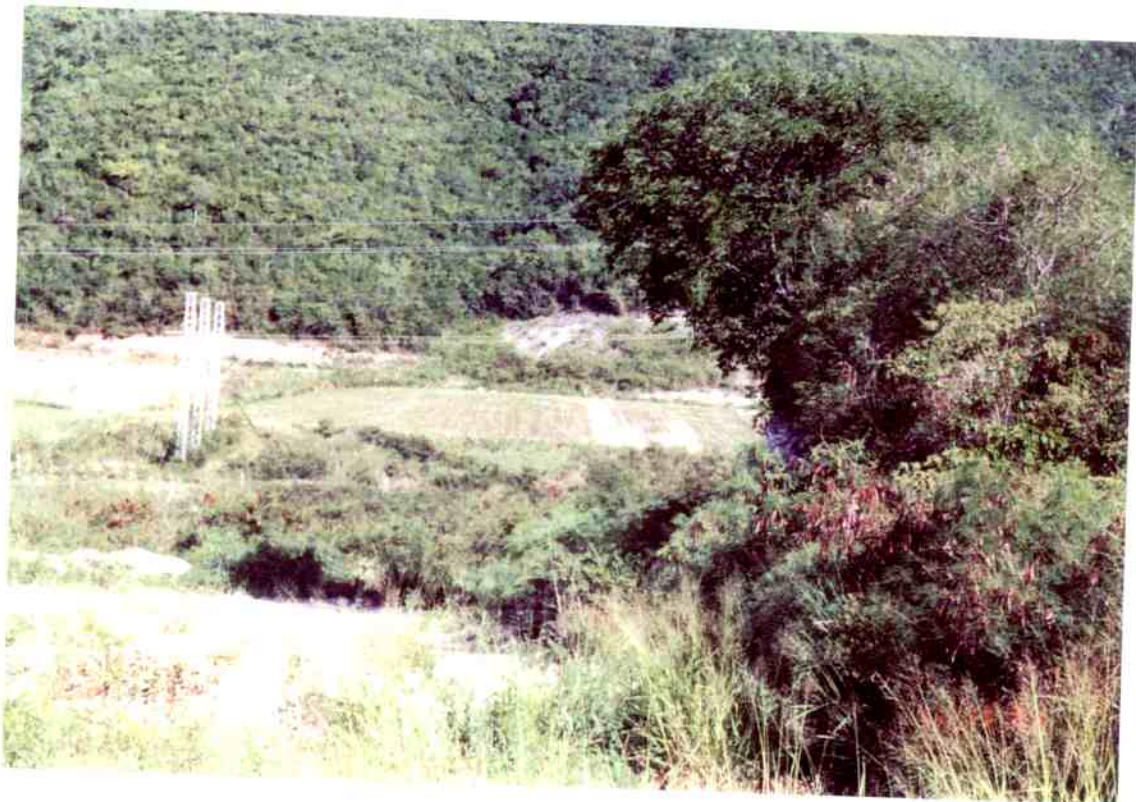
View of Recent Maintenance Activity on East Slope of Unit 2/3 Looking Northwest

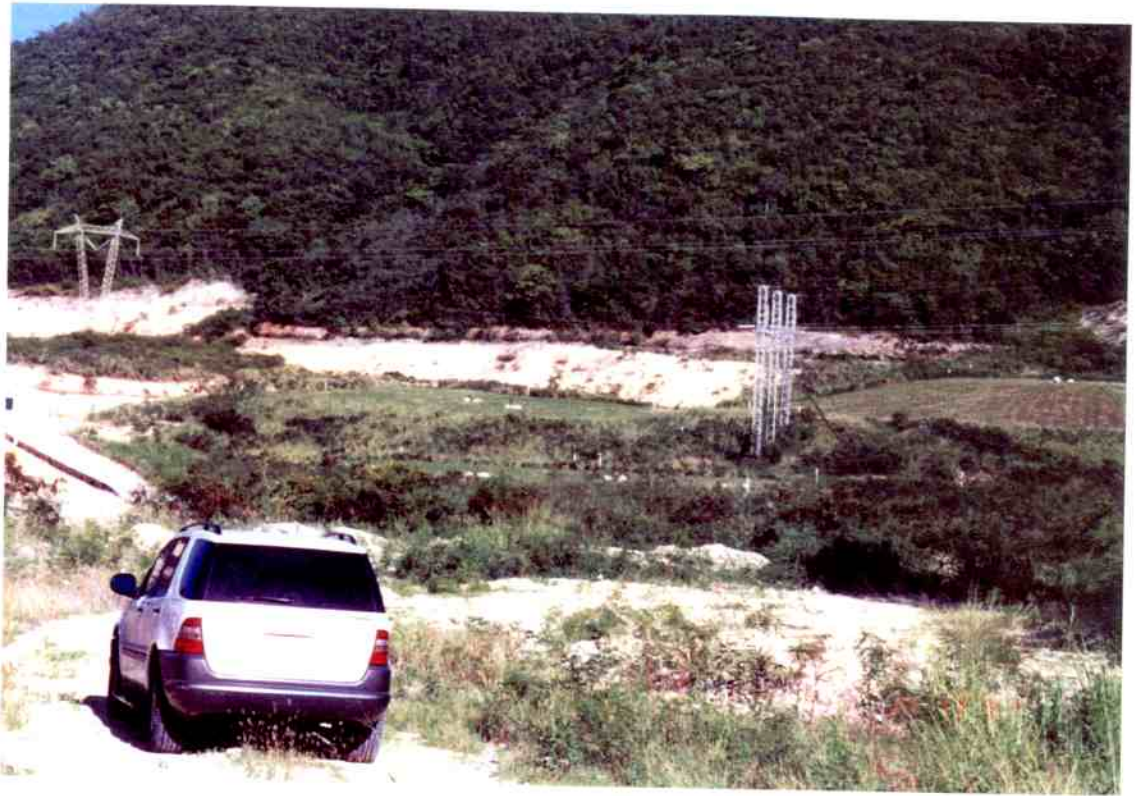
View of Units 1, 2/3 & 5 Looking Northwest

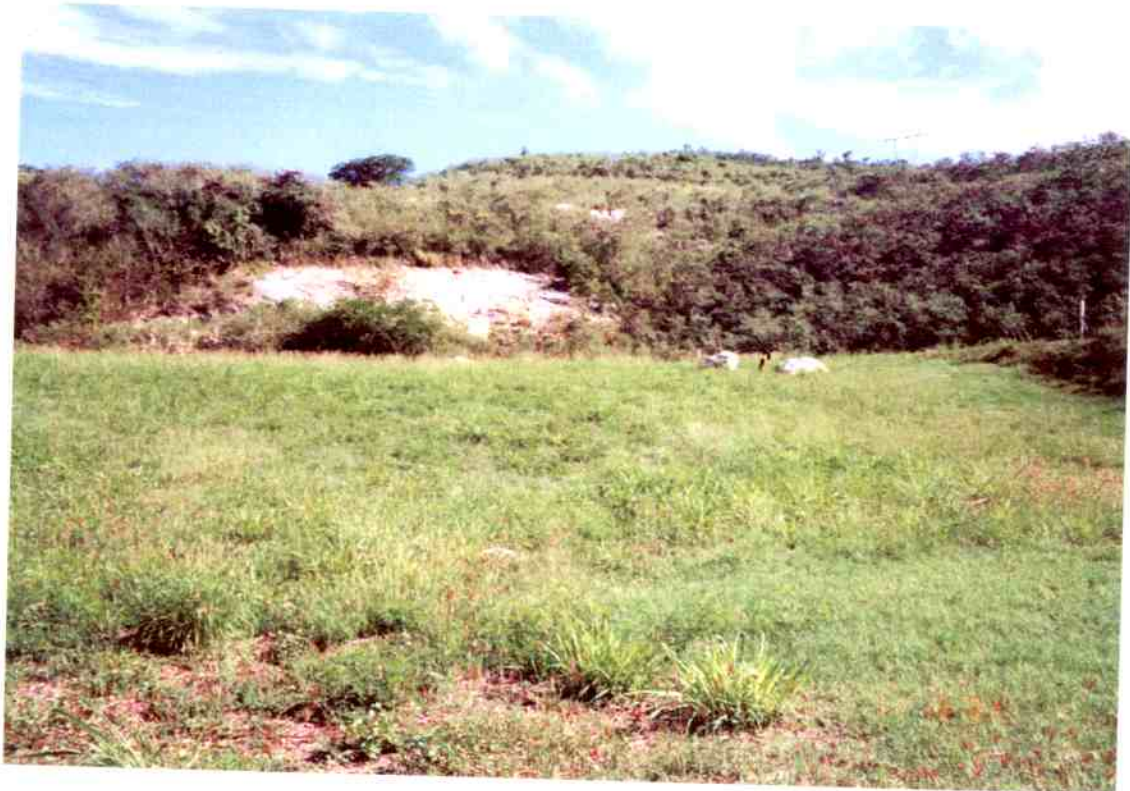
View of Top of Unit 10/11 Looking North

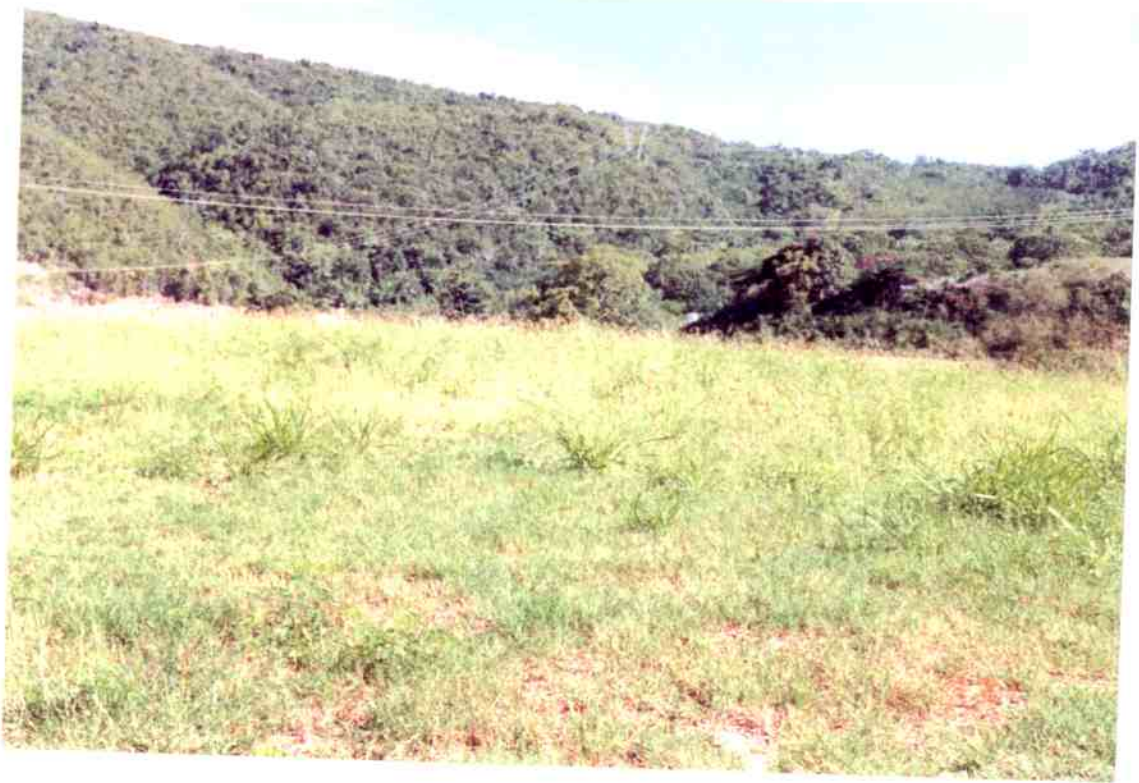
View of Top of Units 9 & 10/11 Looking North

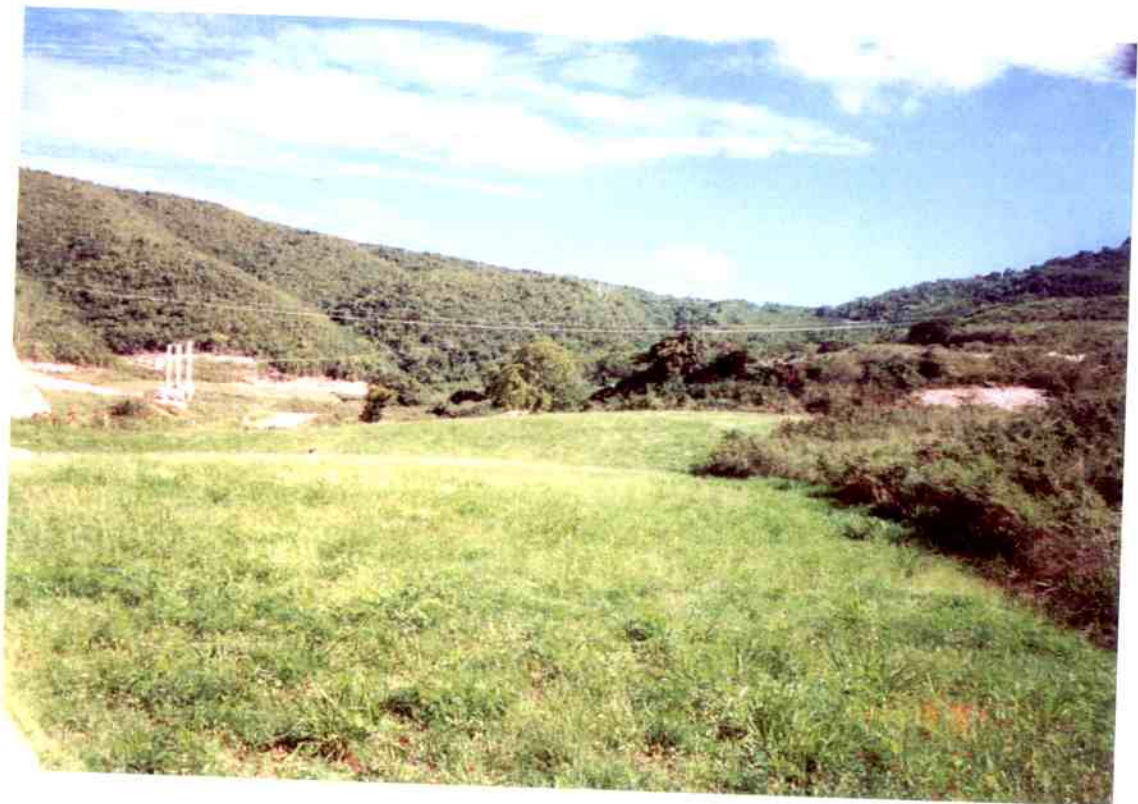
View of Top of Units 9 & 10/11 Looking North from Unit 13

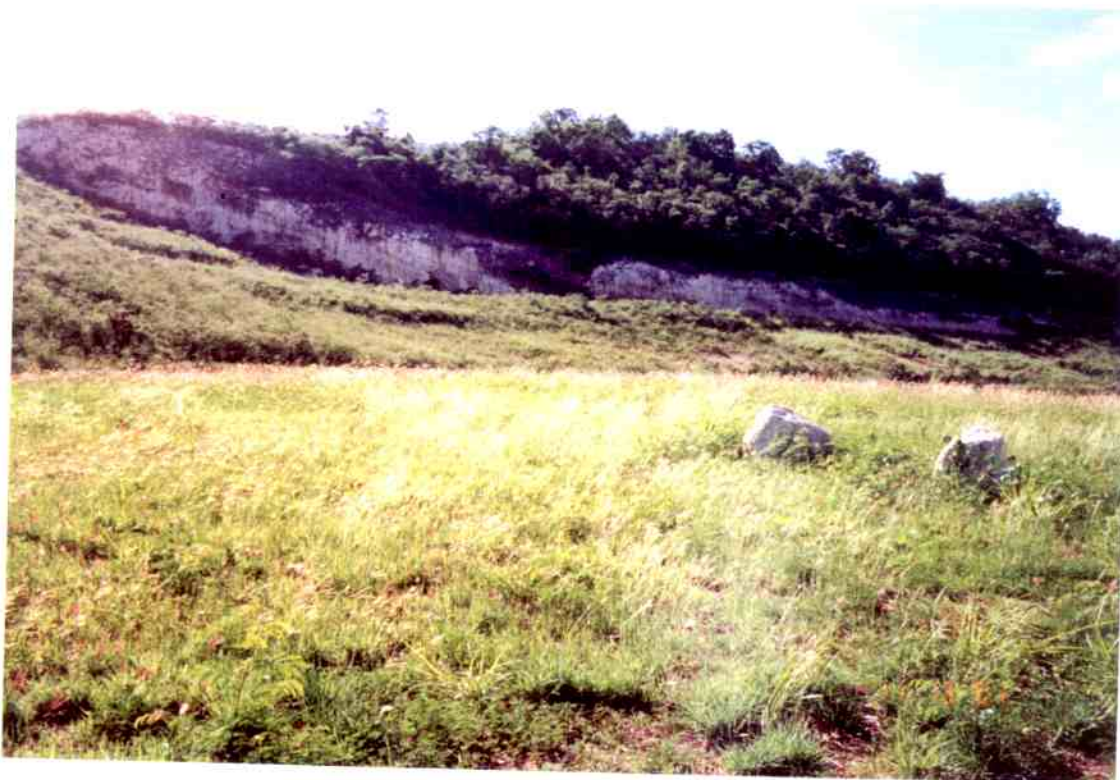
View of Top of Units 10/11 Looking Southeast

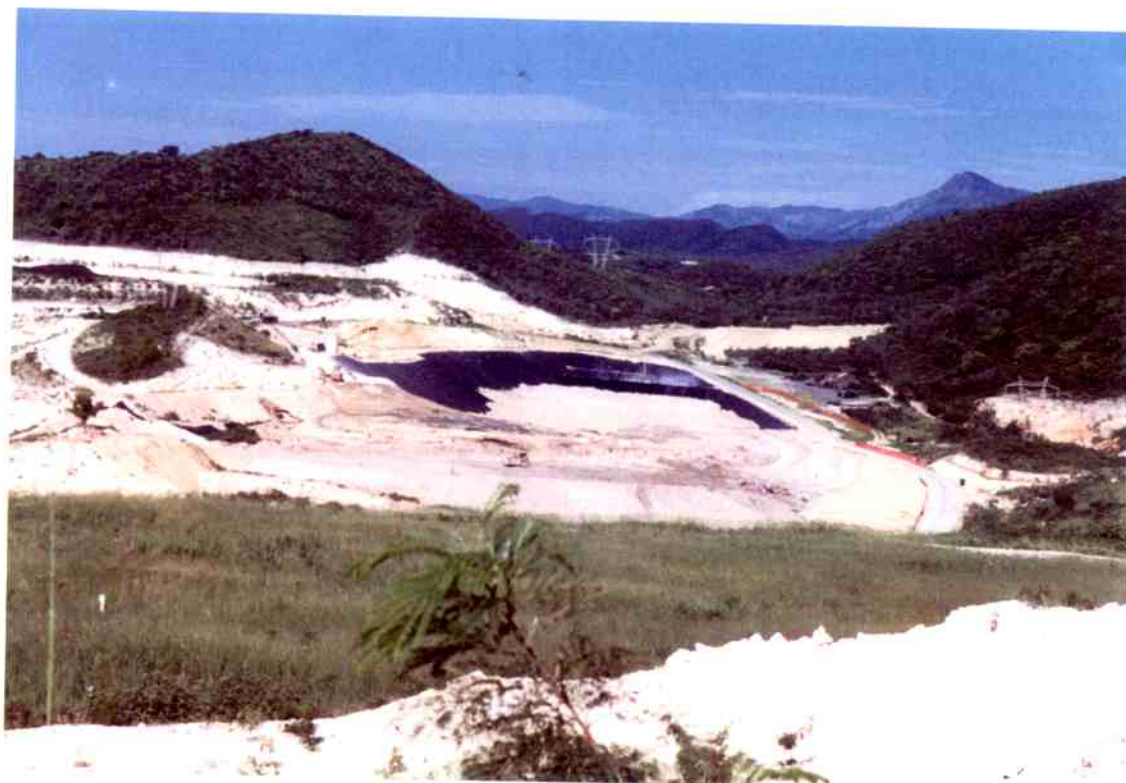
View of Top of Units 9 & 10/11 Looking West
